Manhole Inspection Summary

Manhole # S25EE2001MH

Insp Date: **10/31/06 2:24 PM**

Location Address: **5709 ROLAND AVE**

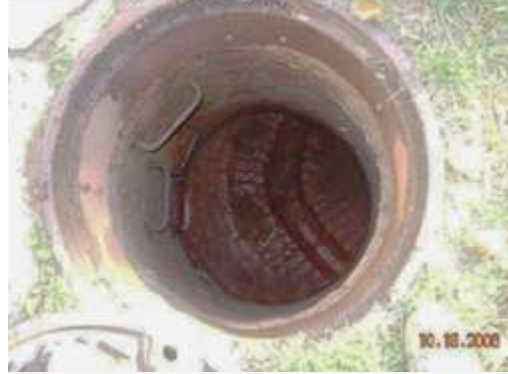
Top View

Evidence of surcharge - Bench debris.

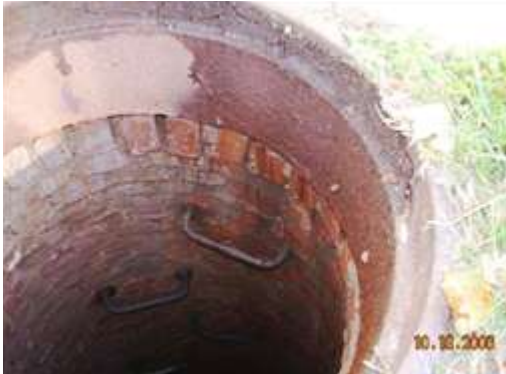
Defect

Frame Offset: **1** (in.) Condition: ☐ Sound ☐ Cracked ☒ **Leaks**

Condition: ☐ Sound ☐ Cracked ☐ Root Intrusion ☐ Loose Brick ☒ **Deteriorated**

Infiltration: ☐ None ☒ **Joint** ☐ Cracks ☒ **Mortar** ☐ Roots ☐ Wall

Frame leaks. Adjustment deterioration and infiltration. Corbel and Barrel infiltration.

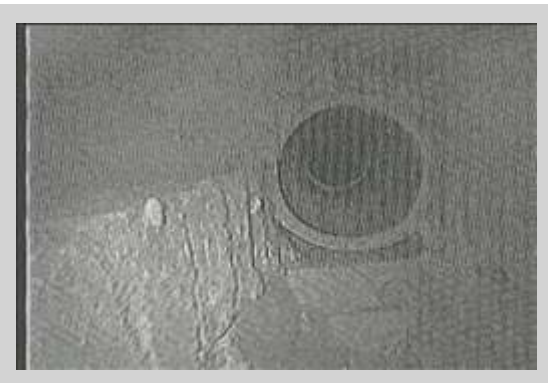
8 in. Circular Gravity Sewer Pipe In @ 4 O'Clock

Comments **The I4 pipe picture shows Channel deterioration.**

Infiltration: **Evidence** Pipe Seal Cond: **Cracked**
